<p>COMMISSION INTERNATIONALE DES GRANDS BARRAGES ----- XXV CONGRES DES GRANDS BARRAGES <i>Stavanger, juin 2015</i> -----</p>	<p>Q. 99</p>
--	--------------

**SAFETY INVESTMENTS IN HORCAJO DAM (SPAIN): A PROCESS
INFORMED BY THE APPLICATION OF SPANCOLD GUIDELINES ON RISK
ANALYSIS (*)**

Manuel SETRAKIAN
Gobierno de Extremadura

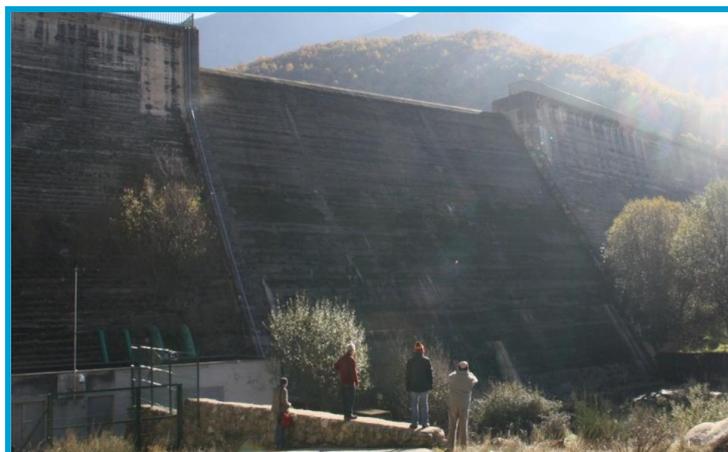
Fig. 1

A significant part of the dam body, including all the central part and the left abutment were founded on an alluvial heterogeneous soil. This fact has raised concern on the integrity of the foundation and its potential for being eroded. To address such concern, during the first years of the dam operation (90s') a series of foundation resistance improvements were performed and, since 2007, water pool level has been restricted to lower the risk of excessive leakage and structural instability.

Once a working group was conformed including owner, regulator and external consultant personnel, and a site visit inspection performed there was a common understanding and consensus on the issues that seem not to comply with sufficient low risk according to modern safety standards (in a broad sense), namely foundation integrity and resistance. Moreover, some of the working group members expressed concern on sliding stability, the emergency preparedness, hydrologic adequacy of outlet work, the effectiveness of drainage and reliability of instrumentation and monitoring system.

Dam view from downstream (photo taken during the inspection)
Vue frontale du barrage pendant une visite d'inspection

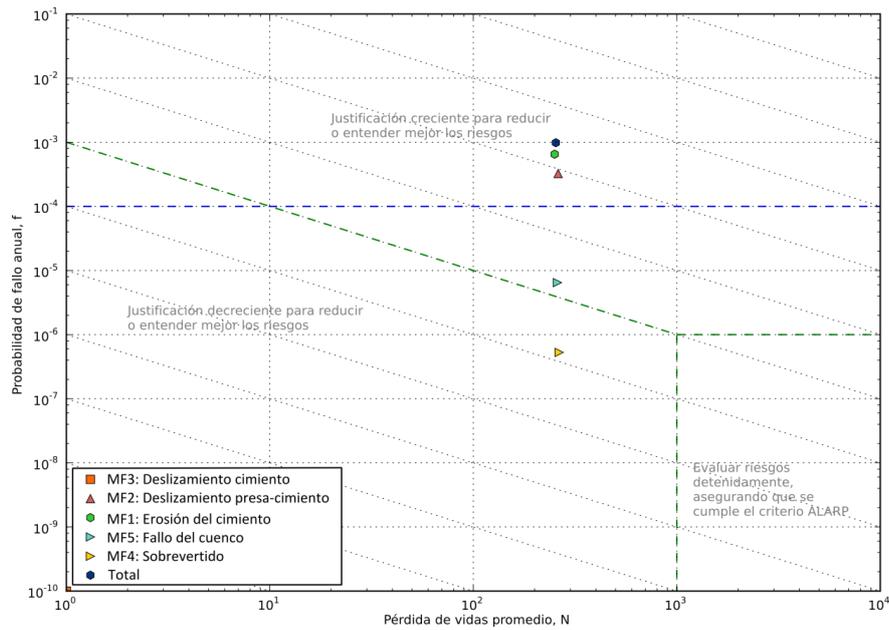
Fig.3
Current risk estimates plotted versus USBR (2011) tolerability guidelines
Evaluation de risque existant conformément à USBR (2011)

As can be inferred from Fig. 3, “El Horcajo” dam would not be aligned with a sufficiently low risk values, thus action is strongly supported to reduce such risk. Two main contributors to risk are (1) Foundation erosion followed by structural collapse and (2) Sliding along dam-foundation contact.

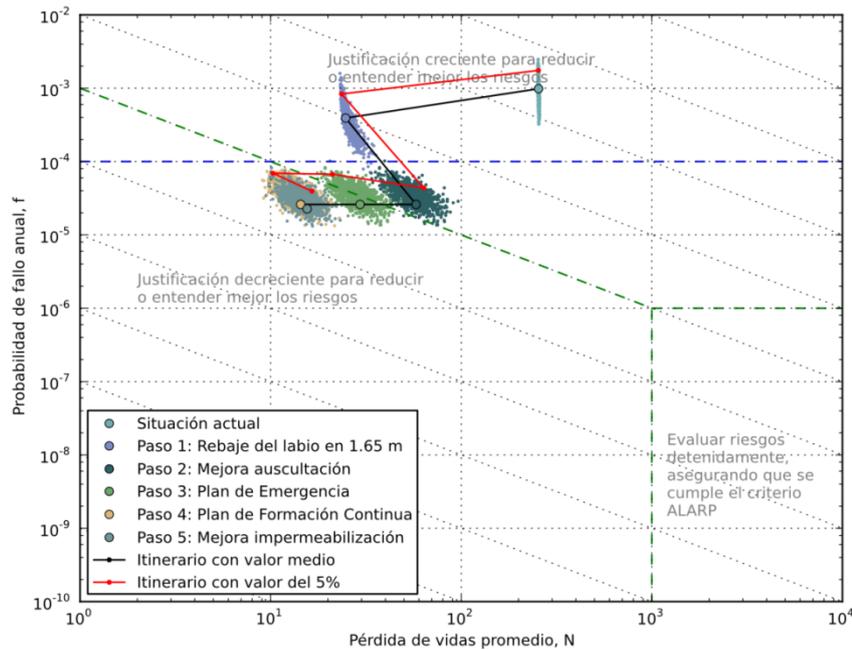
Fig. 4
 Secuencia priorizada de alternativas de actuación
 Séquence d’alternatives d’actuation priorisée

Three first alternatives identified in both itineraries in the same order are (1) lowering the spillway crest by 1.65 meters, (2) upgrading the monitoring system including new instrumentation devices and (3) Emergency Action Plan implementation, without questioning the suitability and utility of all the considered safety investments evaluated.
